UPDATE TO PRELIMINARY REPORT ON ACCIDENT AT TURØY, NEAR BERGEN, NORWAY ON 29 APRIL 2016, INVOLVING AIRBUS HELICOPTERS H225, LN-OJF OPERATED BY CHC HELIKOPTER SERVICE AS

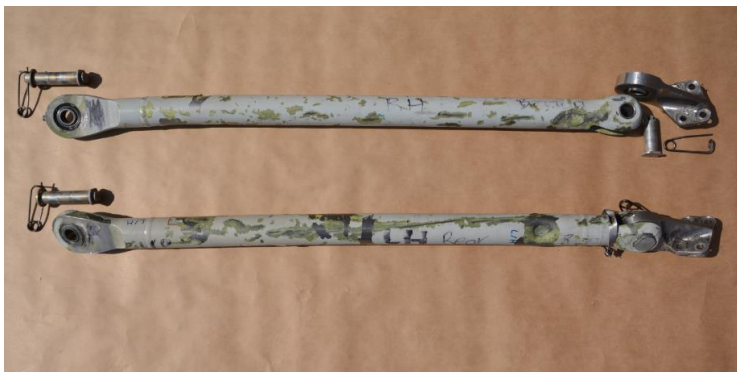
Figure 3: MGB Right and left hand aft suspension bars with attachment fittings. Photo: AIBN

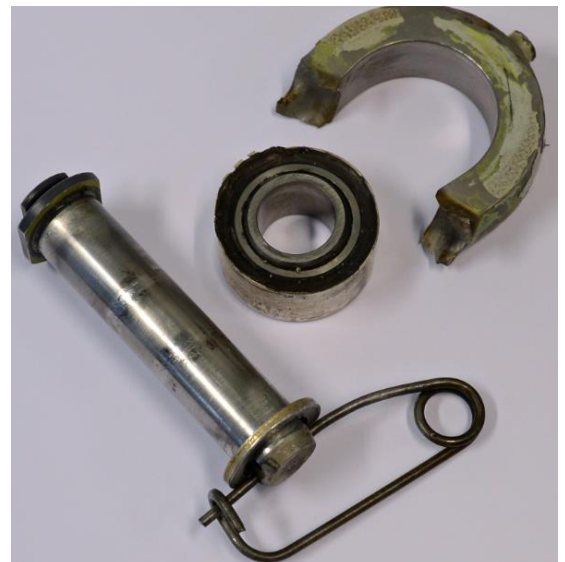
Figure 4: Upper forward suspension bar fitting. Photo: AIBN

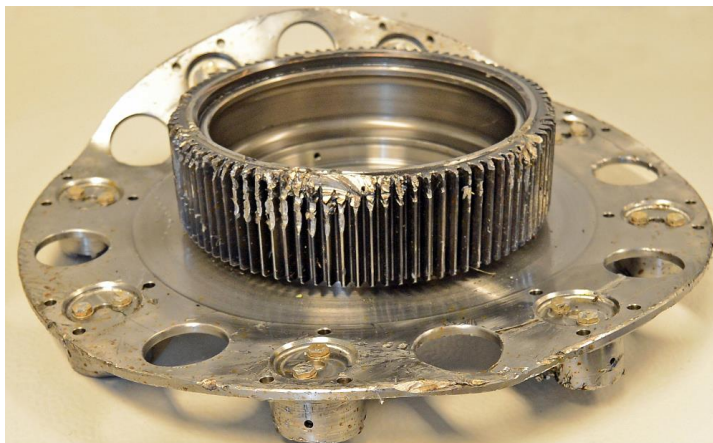
Figure 5: MGB first stage planetary gear carrier. Photo: AIBN

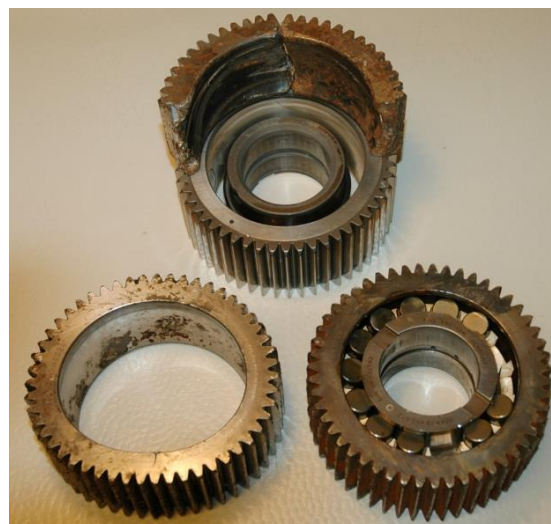
Figure 6: Parts from second stage planet gear.
(The fractured gear is placed on top of a sample gear that was not involved in the accident.)
Photo: AIBN

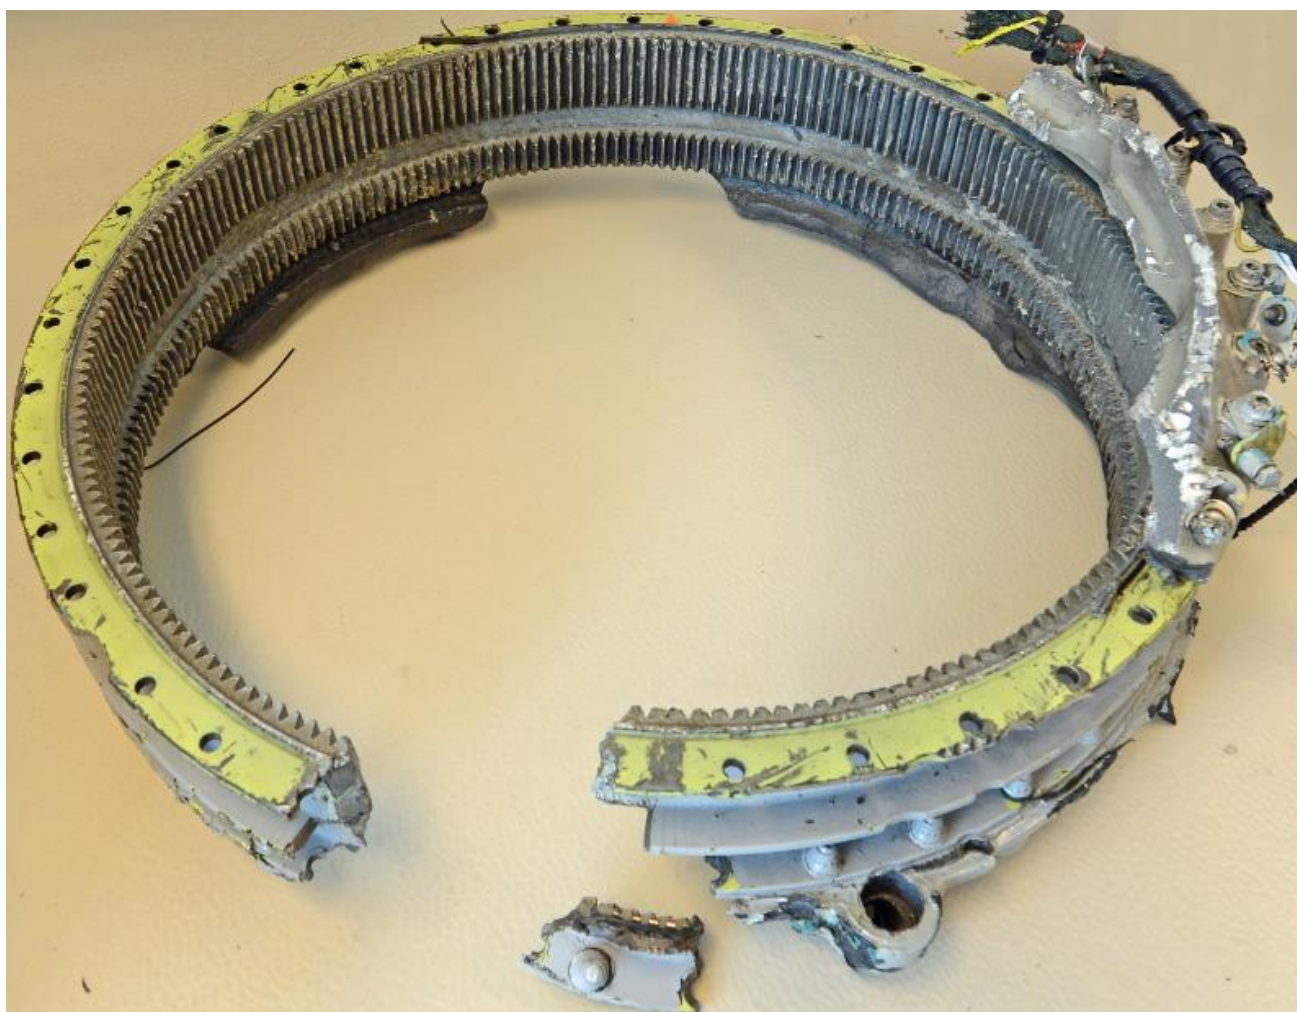
Figure 7: Ring Gear. Photo: AIBN

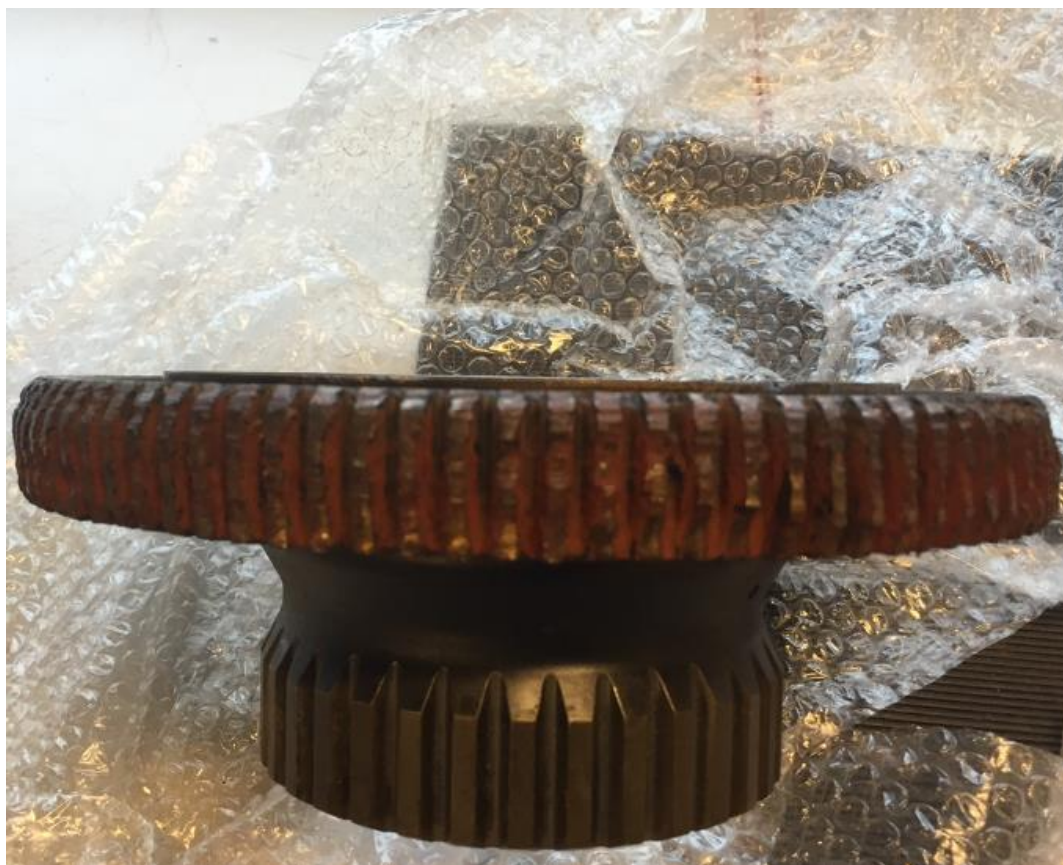
Figure 8: First stage Sun Gear. Photo: AIBN

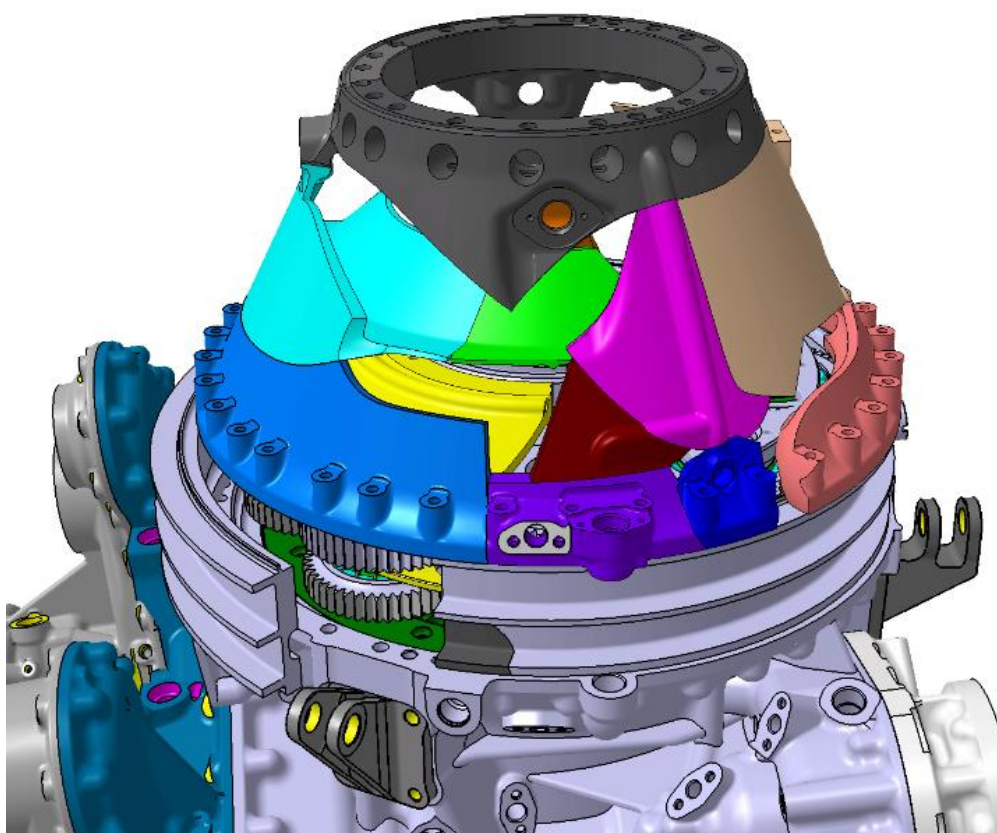
Figure 9: Illustration of how the retrieved fragments of the Conical Housing are pieced together in order to look for break-up sequence/mechanism. Illustration: Airbus Helicopters

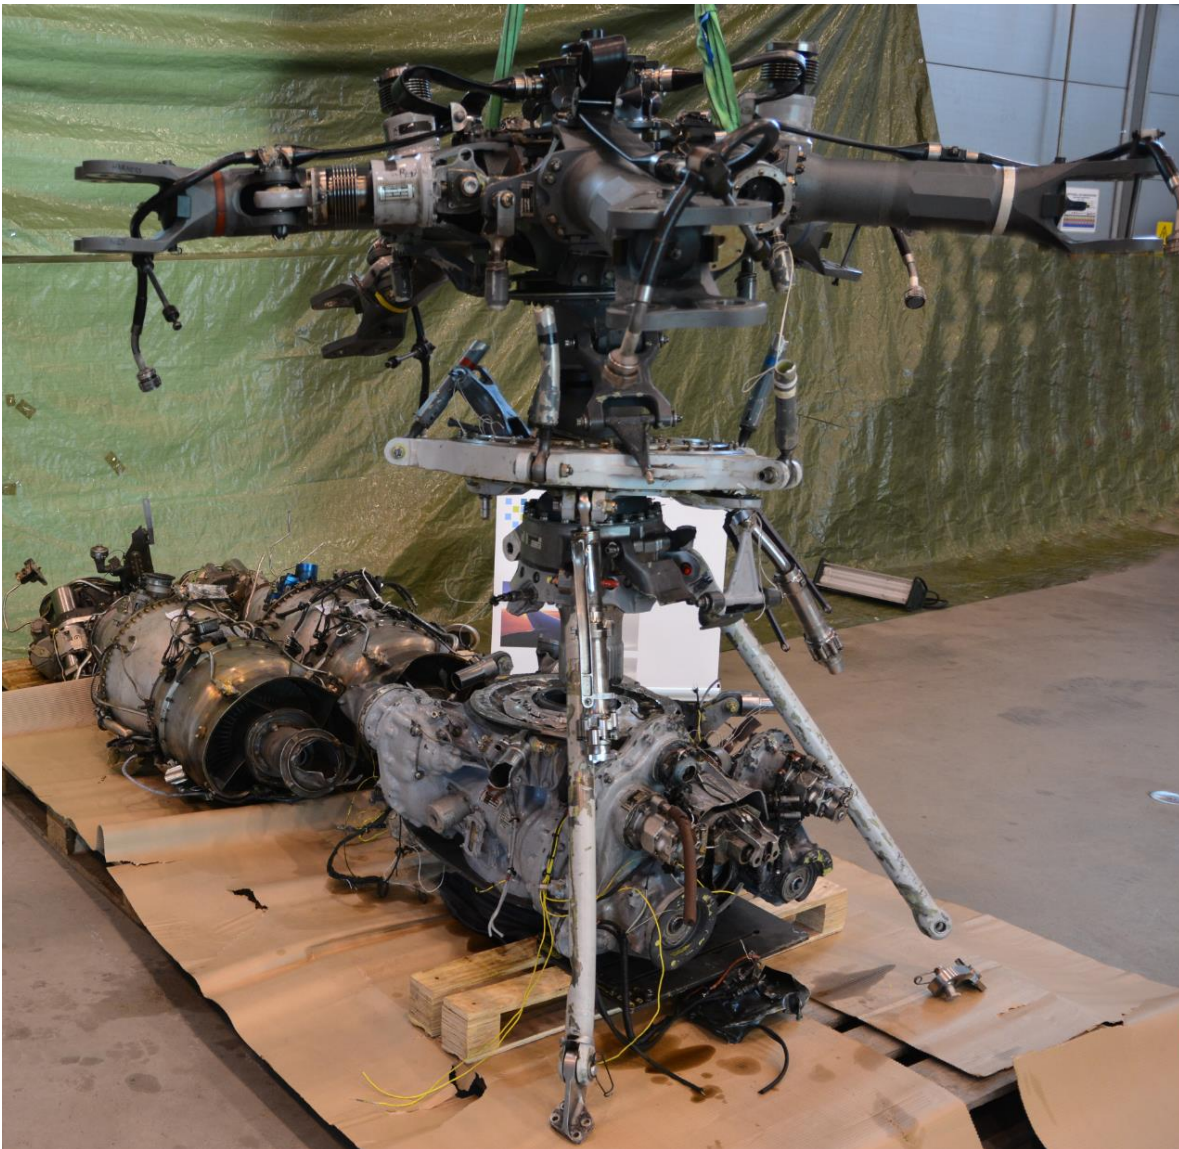
Figure 10: Main rotor head with rotor mast with aft suspension bars and power plants. Photo: AIBN
